**Flood Control Project Maintenance  
Levee Inspections**

**Maintenance Issue Types Only, Levee Inspection Report By Mile - Fall 2018**

**Reclamation District No. 0817 Carlin**

Waterway	Bank	Unit Miles	Inspection Start/End	Inspector
Unit No. 01 South Dry Creek	Left	3.81	11/01/2018 11/01/2018	Sterling York

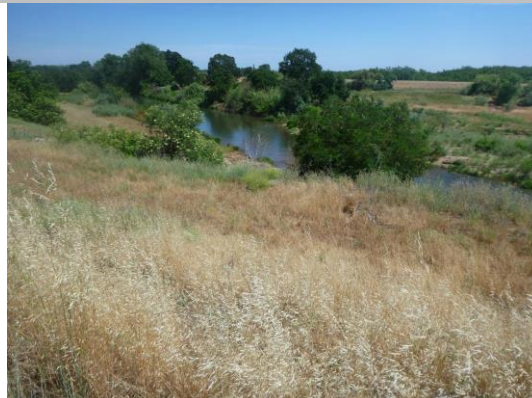
Photo 3 of 3 : LEVAL\_FA\_2018\_162\_289.jpg

LM Start	<b>2.08</b>	Rating **	A/W	Issue No.	<b>13 (cont)</b>
LM End	<b>3.18</b>	Issue Type +	Ma	Location *	
Category	Supplemental		GPS Latitude/Longitude		
			Start	End	
Item	2017 Storm Damage		38.989338°	38.994124°	
			-121.468640°	-121.449448°	
DWR ID	DWR_RD0817_02_f_2017_13

Repair Type: Stability
